# A model test on an open-cut tunnel structure under the effect of a stick-slip normal fault

Zhiqiang Zhang, Xingyu Zhu and Ronghua Wei

*School of Civil Engineering, Southwest Jiaotong University, Chengdu, China and  
Key Laboratory of Transportation Tunnel Engineering, Ministry of Education,  
Southwest Jiaotong University, Chengdu, China*

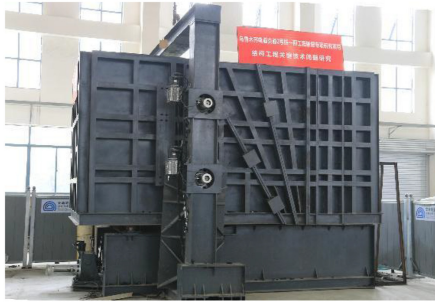
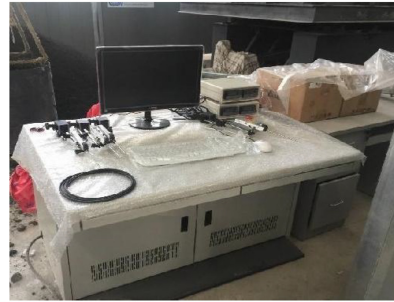
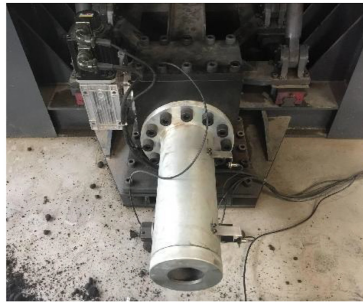
**Figure 5.**  
Images of the test  
device and components  
for simulating loading  
and fault dislocation

Test system to simulate loading and fault rupture  
(a)

Data acquisition and loading control system  
(b)

High-speed screw loading system  
(c)

The model test system was designed to simulate loading and fault rupture (as shown in Figure 5a), which was monitored with a data acquisition and loading control system (as shown in Figure 5b). The loading model test system was mainly composed of the box body,

a vertical screw loading device, a horizontal screw loading device, a thrust transmission device, a reaction frame and a base. The box body of the device ( $5 \times 2.5 \times 2.5$  m) was provided with shear-slip joints of  $60^\circ$ ,  $75^\circ$  and  $90^\circ$ . The bottom of the box was the base; and a reaction frame was fixed onto the base on both sides of the box. The high-power-high-speed screw loading system was installed underneath the bottom plate of the left footwall box body (as shown in Figure 5c), which caused the box body to move along the preset shear joints. The supporting computer digital servo control system controlled the screw loading rate and recorded the loading-time history curve. The system device had the following characteristics: (1) The large proportions and the size of the test device realized the coverage of the fault hanging wall, the footwall and tunnel structure within 125 m of the longitudinal range of the tunnel, ensuring the monitoring of the affected area of strata and tunnel structure under the simulation of fault dislocation, and provided better boundary conditions. (2) It realized multi-angle fault dislocation, and in the process of dislocation, the high-speed screw loading system provided a high-speed and stable loading rate, and the data acquisition system realized real-time monitoring of test data.

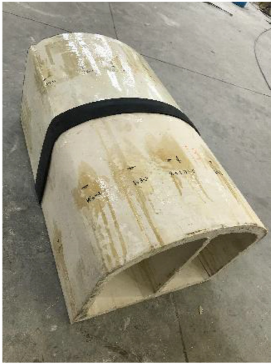
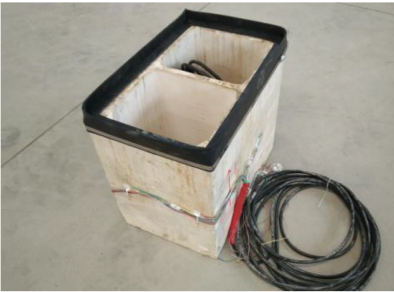
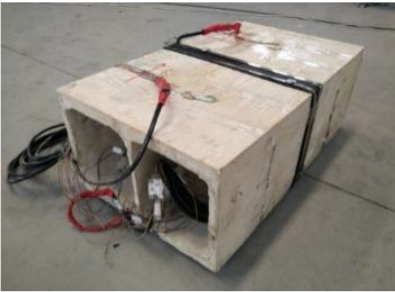
**Figure 9.**  
Segmented rubber  
waterproof belt  
connection of tunnel  
sections used in  
the model

Special “T”-type rubber waterproof belt  
(a)

Double-line box arch tunnel  
(b)

Double-line box tunnel  
(c)

In this model, two comparative test conditions using a double-line box section tunnel and an improved double-line box arch section tunnel were designed and conducted (as shown in Table 3). The longitudinal length of the plaster tunnel model was divided into 24 cm and 36 cm segments, and the T-section rubber ring was used to connect each segment (as shown in Figure 9). The rubber material was the same as the actual project EPDM (Ethylene Propylene Diene Monomer) rubber, and the material strength was customized by the manufacturer according to similar theoretical requirements. This special flexible, joint water-stop belt had strong elasticity, good water insulation, corrosion resistance and other advantages (see Table 4 for physical and mechanical parameters). It was applied to simulate the flexible hinged mode and water-stop belt connection between the sections and constituted a complete tunnel model with a total length of 5 m.

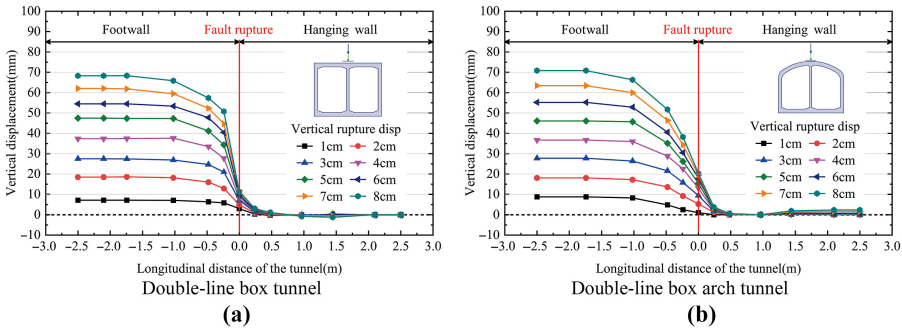
Figure 13.  
Vertical displacement  
curve of vault

Figure 13 shows the longitudinal distribution curves of the vertical displacement of the tunnel vault under the two cross-sectional types. It can be seen from the figure that the vertical displacement of the vault of the tunnel lining structure was mainly within the range  $-2.5\text{--}0.5\text{ m}$  ( $-5.2\text{--}1.1\text{ D}$ ,  $\text{D}$  being the tunnel span), and the vertical displacement increased with the increase in the fault distance. The maximum vertical displacement of the double-line box tunnel vault was 6.8 cm (actual 170 cm dislocation momentum), and the maximum vertical displacement of the double-line box type arch tunnel vault was 7.1 cm

(actual 177.5 cm dislocation momentum). The maximum vertical displacement of the tunnel vault was less than the experimental dislocation amount of 8.0 cm (the actual dislocation amount of 2.00 m), owing to the compression between the stratum and the tunnel during the process of stratum uplift.

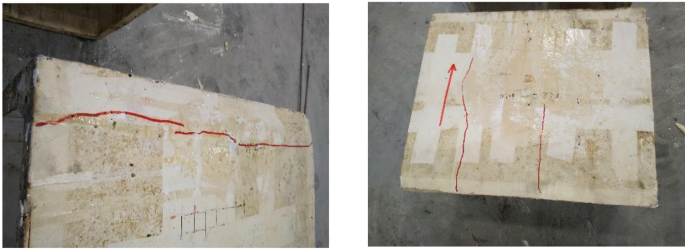
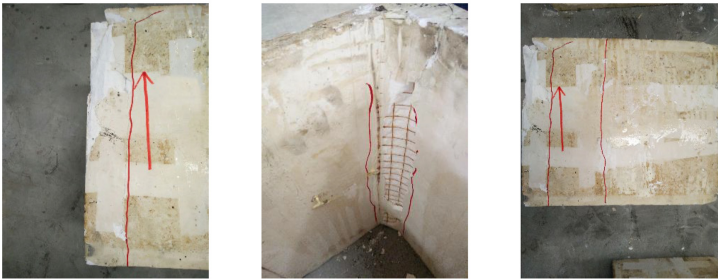
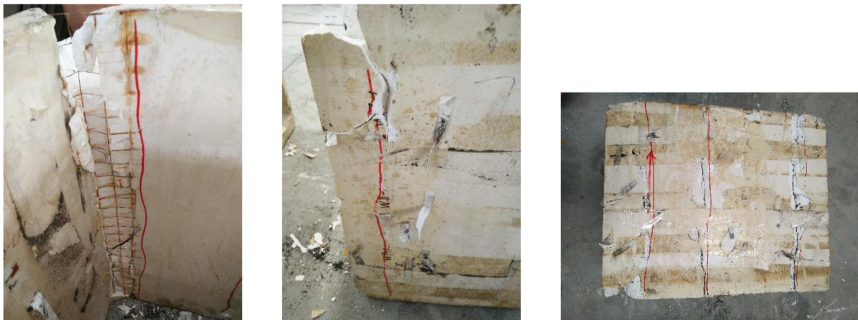
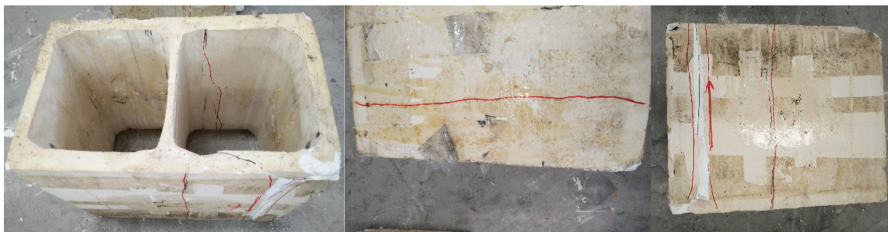
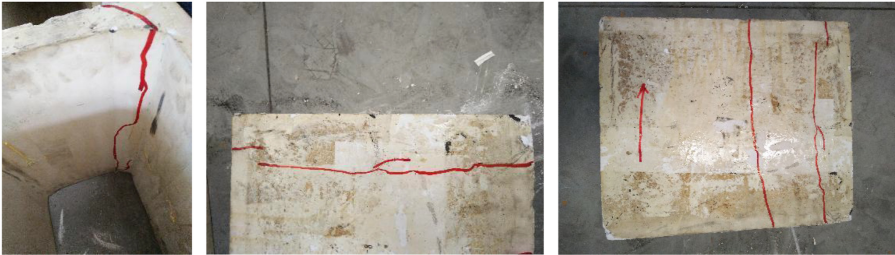
**Figure 20.**  
Tunnel segment  
cracking

4.5.1 Double-line box tunnel. Figure 20 shows the damage pattern of the double-line box tunnel lining at the end of the test. According to the distribution of tunnel cracks, the continuous crack expansion diagram of each segment is drawn, as shown in Figure 21. The crack pattern, number of cracks and crack locations are summarized in Table 5.

- (1) Cracks appeared in the #7–#12 segments of the tunnel lining, with only longitudinal cracks.

Cracked segment of lining structure (7#)  
(a)

Cracked segment of lining structure (8#)  
(b)

Cross-fault cracked section of lining structure (9#)  
(c)

Cracked segment of lining structure (10#)  
(d)

Cracked segment of lining structure (11#)  
(e)

Cracked segment of lining structure (12#)  
(f)

- (2) The largest number of cracks and the most serious damage were found in the #9 segments, which were affected by the direct shear of the fault surface.
- (3) The longitudinal crack depth was the largest in the #9–#10 segments, and there were many fractures along the longitudinal cracks. The longitudinal fractures were mainly concentrated at the intersection angle of the middle wall with the baseplate and roof, accompanied by a large number of spalling blocks and obvious exposure of the reinforcement mesh. There were also obvious longitudinal cracks at the middle wall. Since the middle wall and multiple right-angle structures improved the shear and

longitudinal bending resistance of the tunnel lining structure, no oblique cracks (shear cracks) and circumferential cracks developed during the test.

- (4) The damage range of the tunnel structure in the hanging wall was significantly larger than that of the footwall. When the staggered distance reached 8.0 cm (actual 200 cm misalignment), the damage range of the tunnel structure in the hanging wall was about 140 cm, and the damage range of the tunnel structure in the footwall was about 100 cm.

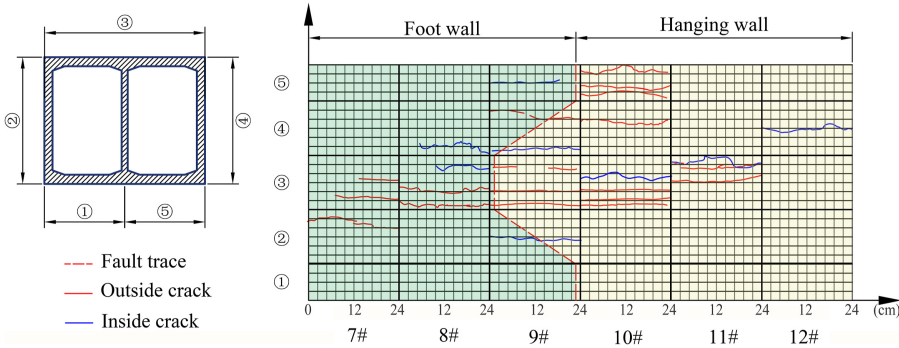
Figure 21.  
Tunnel crack  
expansion diagram

It can be seen from Figures 21 and 23 that the damage degree of the double-line box tunnel is obviously serious compared with the double-line box arch tunnel. The length and number of

cracks in the lining failure are much larger than those in the double-line box arch tunnel. The failure segments of the double-line box arch tunnel are mainly concentrated in 8#, 9# and 10#, while the failure segments of the double-line box arch tunnel are mainly concentrated in 7#, 8# and 9#. In terms of fracture morphology, the longitudinal fracture is the main failure mode of the two sections of tunnels, which indicates that the failure mode is the large eccentric tensile failure. In practical engineering, it should be considered to add the circumferential reinforcement.

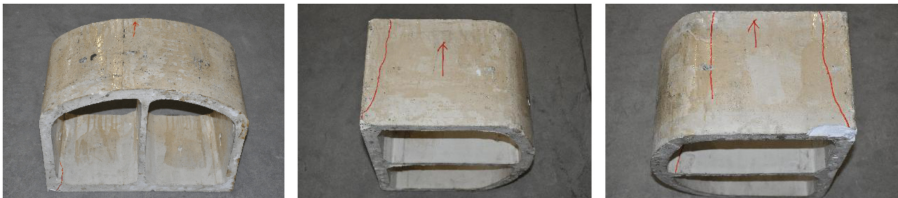
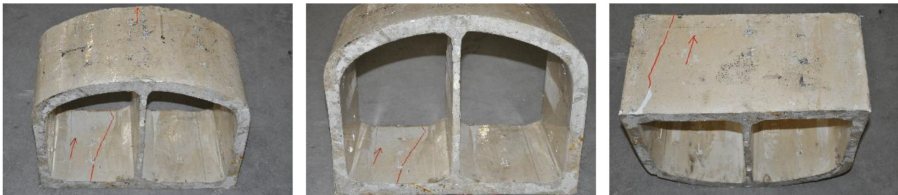
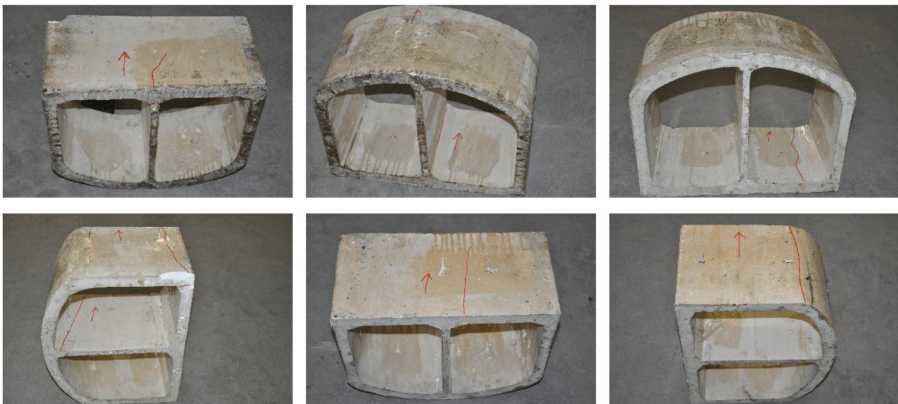
**Figure 22.**  
Tunnel segment  
cracking

**4.5.2 Double-line box arch tunnel.** Figure 22 shows the damage pattern of the structure of the double-line box arch tunnel at the end of the test. According to the distribution of tunnel cracks, the continuous crack expansion diagram of each segment is drawn, as shown in Figure 23. The crack pattern, number of cracks and crack locations are summarized in Table 6.

- (1) Cracks appeared in the #7–#12 segments of the tunnel lining, with longitudinal cracks dominating. The cracks mainly appeared on the inside and outside of the baseplate, the outside of the wall foot and the outside of the arch foot.

- (2) The location of longitudinal cracks was basically consistent with the longitudinal distribution of surrounding rock pressure, indicating that the large local load on the cross-section caused an excessive local bending moment in the structure. The tunnel lining structure suffered large eccentric damage and formed longitudinal cracks.

- (3) The middle wall improved the shear and longitudinal bending resistance of the lining structure. There were no oblique cracks (shear cracks) and circumferential cracks after the test. However, owing to the existence of the straight wall foot structure, the stress concentration at the wall foot was obvious, so the number of longitudinal cracks at the wall foot and baseplate was the largest.

- (4) The damage range of the tunnel structure in the hanging wall was significantly larger than that of the footwall. When the staggered distance reached 8.0 cm (actual 200 cm misalignment), the damage range of the tunnel structure in the hanging wall was about 84 cm, and the damage range of the tunnel structure in the footwall was about 60 cm.

Cracked segment of lining structure (7# ~ 8#)  
(a)

Cross-fault cracked section of lining structure (9#)  
(b)

Cracked segment of lining structure (10# ~ 12#)  
(c)
