Thermo-mechanical behavior of CLT beam-to-girder assemblies connected with T-shaped dowelled connections before, during and after fire exposure

Milad Shabanian

Nicole Leo Braxtan

Paper type Research paper

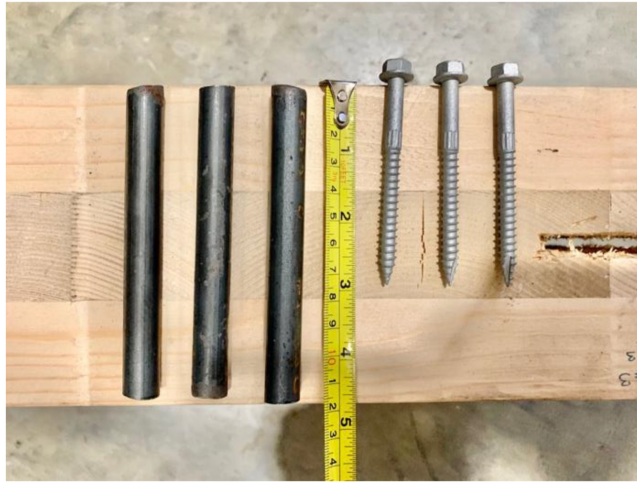
Plate 1.
3-Ply CLT beam, full-length steel dowels and heavy-duty screws

2.2.3 Steel dowels and fasteners. The full-length dowels (120 mm) are cut from 12.7 mm diameter steel rods with similar material properties as the steel connection (ASTM A572 Gr 50). The 6.35 mm diameter heavy-duty hexagonal connector screws with 76.2 mm length and 50.8 mm thread are manufactured from low-carbon steel wire grade 1022. This fastener has 1,130 MPa bending yield strength, 6.36 kN allowable tensile capacity and 3.5 kN allowable shear capacity. Plate 1 shows the steel dowels and screws placed on top of the CLT beam.

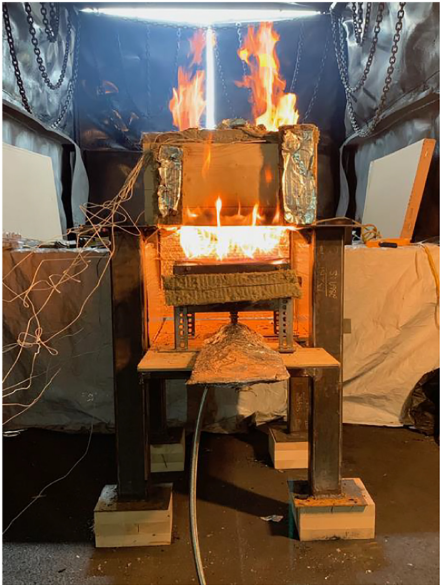
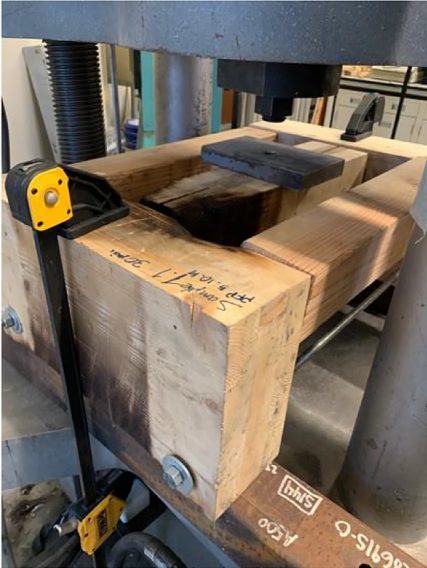
Plate 3.
PFP30 test procedure:
(a) non-standard fire
test and (b) loading at
ambient temperature

Plate 3 shows photos of the two-step PFP test, including 30 min of non-standard fire exposure of approximately 480 °C and subsequent cooling, followed by mechanical loading to failure.

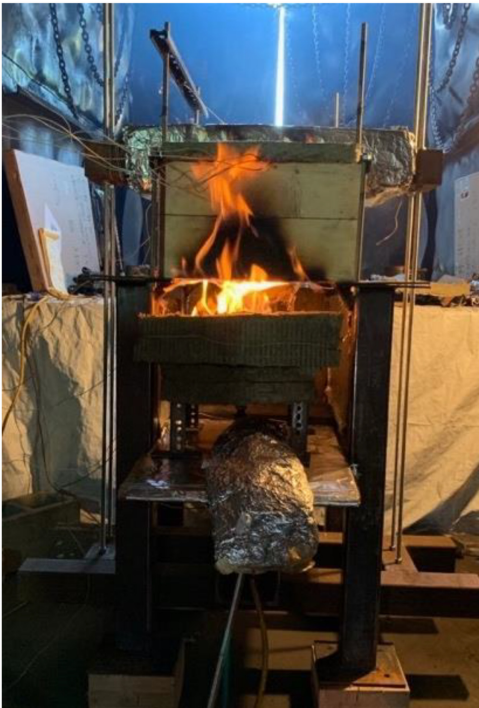
Plate 4.
Fire-performance test
of the CLT beam-to-
girder assembly

Plate 4 shows a photo of the FP test, including the application of constant mechanical load equivalent to 66% of the AT assembly capacity along with non-standard fire exposure of approximately 480 °C until failure. This higher than usual mechanical load was prescribed to

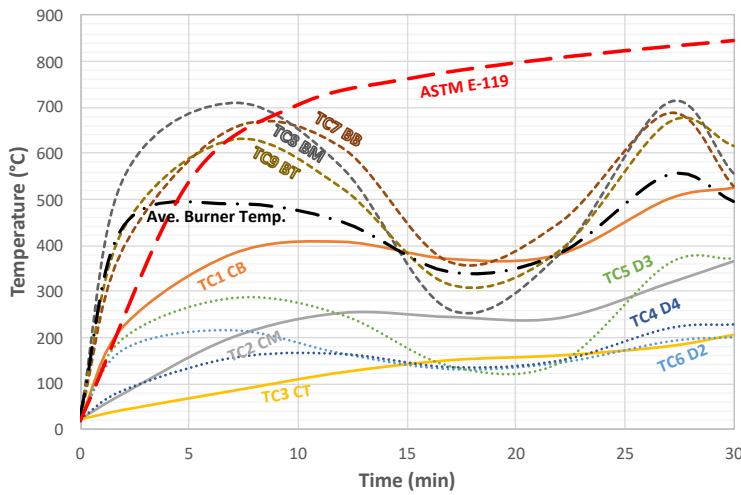
Figure 8.
PFP30 test result; heat
distribution along the
exposed area

Figure 8 shows heat distribution along the sample during the 30 min fire exposure. The burner temperature rapidly increased for the first 3–4 min to approximately 480 °C and then ranged from approximately 340 °C–560 °C for the duration of the fire, with the slight fluctuations in temperature due to the manually control of the gas flow. The figure also shows the ASTM E119 standard fire curve for comparison.

The beam temperatures at the location of TCs 7, 8 and 9 (bottom, middle and top of the beam) reached the wood ignition temperature (300 °C) and then began to increase in comparison to the burner temperature after one minute. Plate 6 shows visual confirmation of ignition over the height of the beam 1 min into the fire test.

Temperature of the three lower dowels at their tips was recorded by TCs 4, 5 and 6. The temperature of the dowel tips followed the same fluctuation pattern as the beam and burner

and reached a maximum temperature of 370 °C. TCs 1, 2 and 3 recorded the temperature at the bottom, middle and top of the steel connection. After 30 min of fire exposure the maximum temperature in the bottom of the connection was 525 °C and the difference between bottom, middle and top of the connection was approximately 140 °C. According to the former studies (Lee *et al.*, 2012; Sajid and Kiran, 2019) the post-fire mechanical properties of ASTM A572 Gr

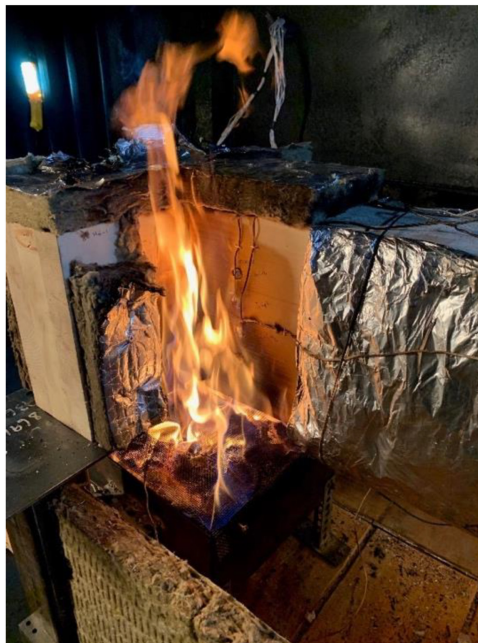
Plate 6.
CLT beam ignited in
the beginning of the
fire test

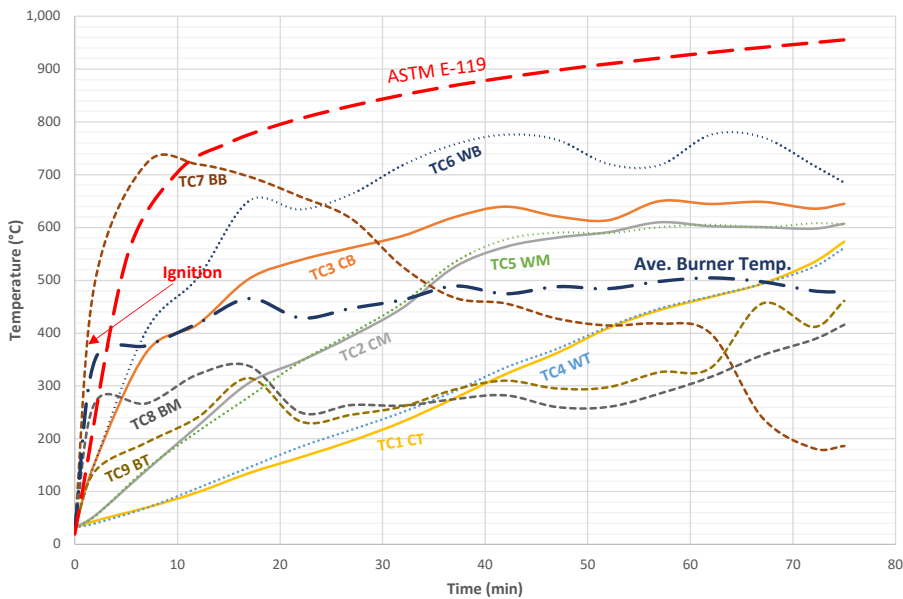
Figure 10.
Heat distribution along
the exposed area
during the fire-
performance test

Figure 10 shows the heat distribution along the exposed area during the FP test. According to the recorded heat distribution, the bottom of the CLT beam ignited after 2 min.

This statement is confirmed by the visual observations and recorded videos. The beam bottom temperature increased until the 9th minute and then decayed for the remainder of the fire loading. The connection temperature reached its maximum temperature of 760 °C after 40 min in the bottom (at the middle and along the edge of the weld). Between minutes 40 and 75 the temperature of the middle and top of the connection increased significantly, and the steel connection reached nearly 595 °C at the end of the test. At these temperatures, a reduction in strength and stiffness of the steel connection is expected. However, due to the reserve strength of the capacity during design, the steel connection itself does not experience failure.

Returning to [Figure 10](#), the temperature of the connection at the time of failure at 55 min was nearly 650°C at the bottom of the connection. At 650°C the steel is expected to maintain only 35% of its AT yield strength. Failure, however, was not observed in the steel connection itself, but instead in the timber elements. This is attributed to the extensive charring that occurred in the timber which in turn weakened the timber and led to the embedment failure in the beam.
